To cite this article: A Grazzini *et al* 2018 *IOP Conf. Ser.: Mater. Sci. Eng.* **372** 012022

# Delamination of plasters applied to historical masonry walls: analysis by acoustic emission technique and numerical model

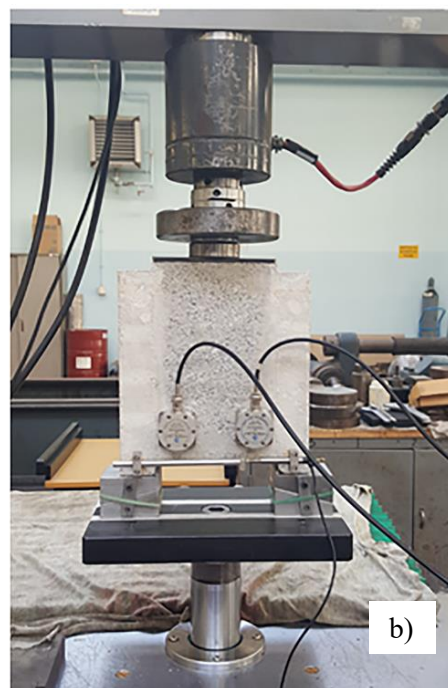
For carrying out tests, a particular geometry of the composite specimen has been proposed. Four mixed specimens were made, applying a 40 mm mortar layer to both shorter faces of the stone brick suitably cut with the dimensions shown in figure 2(a). The mechanical characteristics of the repair mortar and the stone brick were chosen equivalent to those of the stone masonry at the Sacro Monte di Varallo. The hydraulic lime mortar was a pre-blended transpiring product, for dehumidifying repair work on historical masonry damaged by dampness. For this mortar the Young's modulus was 7000 MPa, the compressive strength was 33.8 MPa.

**Figure 2.** Geometry of composite specimen (a) and test setup (b).

The surface of the stone block has been treated specifically by means of a drill to facilitate the mortar's adhesion. This treatment aimed to simulate the real discontinuities on the wall surface that favor the adhesion of the plaster. The application of the dehumidified mortar took place leaving specific and surface symmetrical discontinuities at the top and bottom of the specimen, as showed in figure 2(a). These notches favored the trigger and propagation of multiple cracks, in order to test the adhesion of two linked materials. An inductive horizontal displacement transducer was applied at the bottom of the specimen for the bulging displacements (figure 2(b)). The vertical displacements were recorded by the piston's translation of the 250 kN servo controlled test machine. The composite specimens were tested by monotonous compression load by horizontal controlled opening. Static tests have been performed after 28 days of maturation. The composite specimen rested, through the side layers mortar, on a double system of steel wedges (figure 3). The wedges were coupled by a 1 mm thick Teflon layer for reducing the horizontal friction during the plaster's expansion. The "SM" (Stone brick-Mortar) label has been associated with each specimen with its sequence number.
